Maddox ECE Construction Report

April 23, 2018

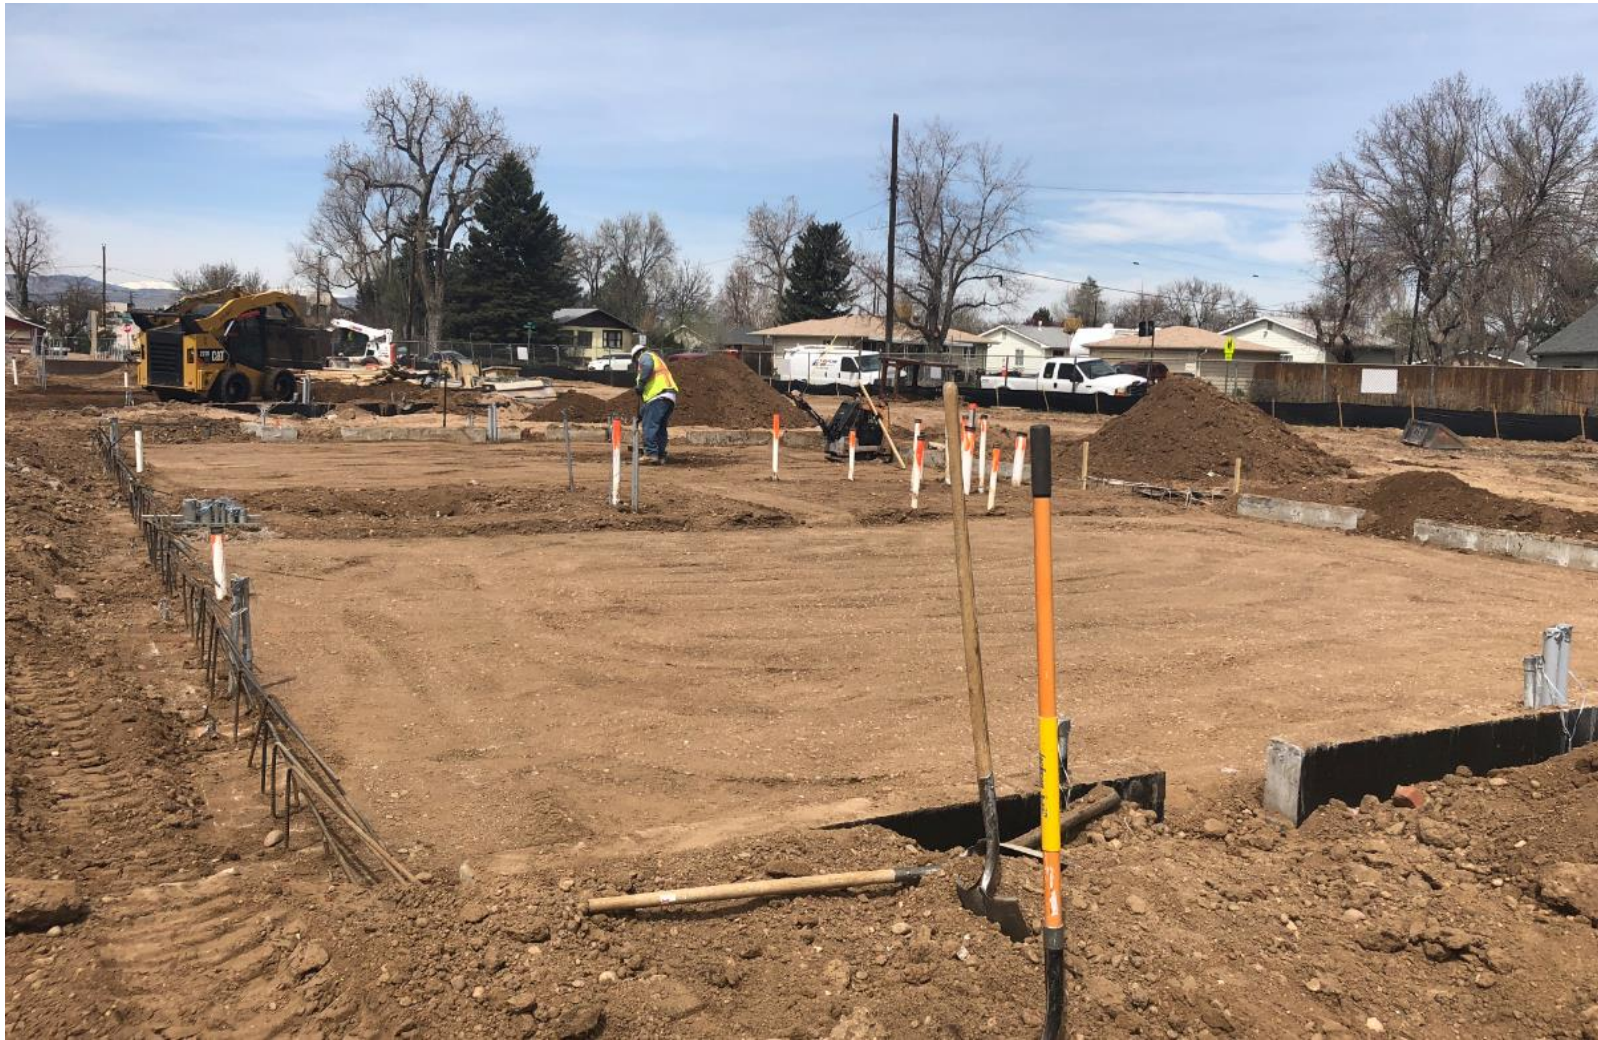
Preparing East wing for floor slab.

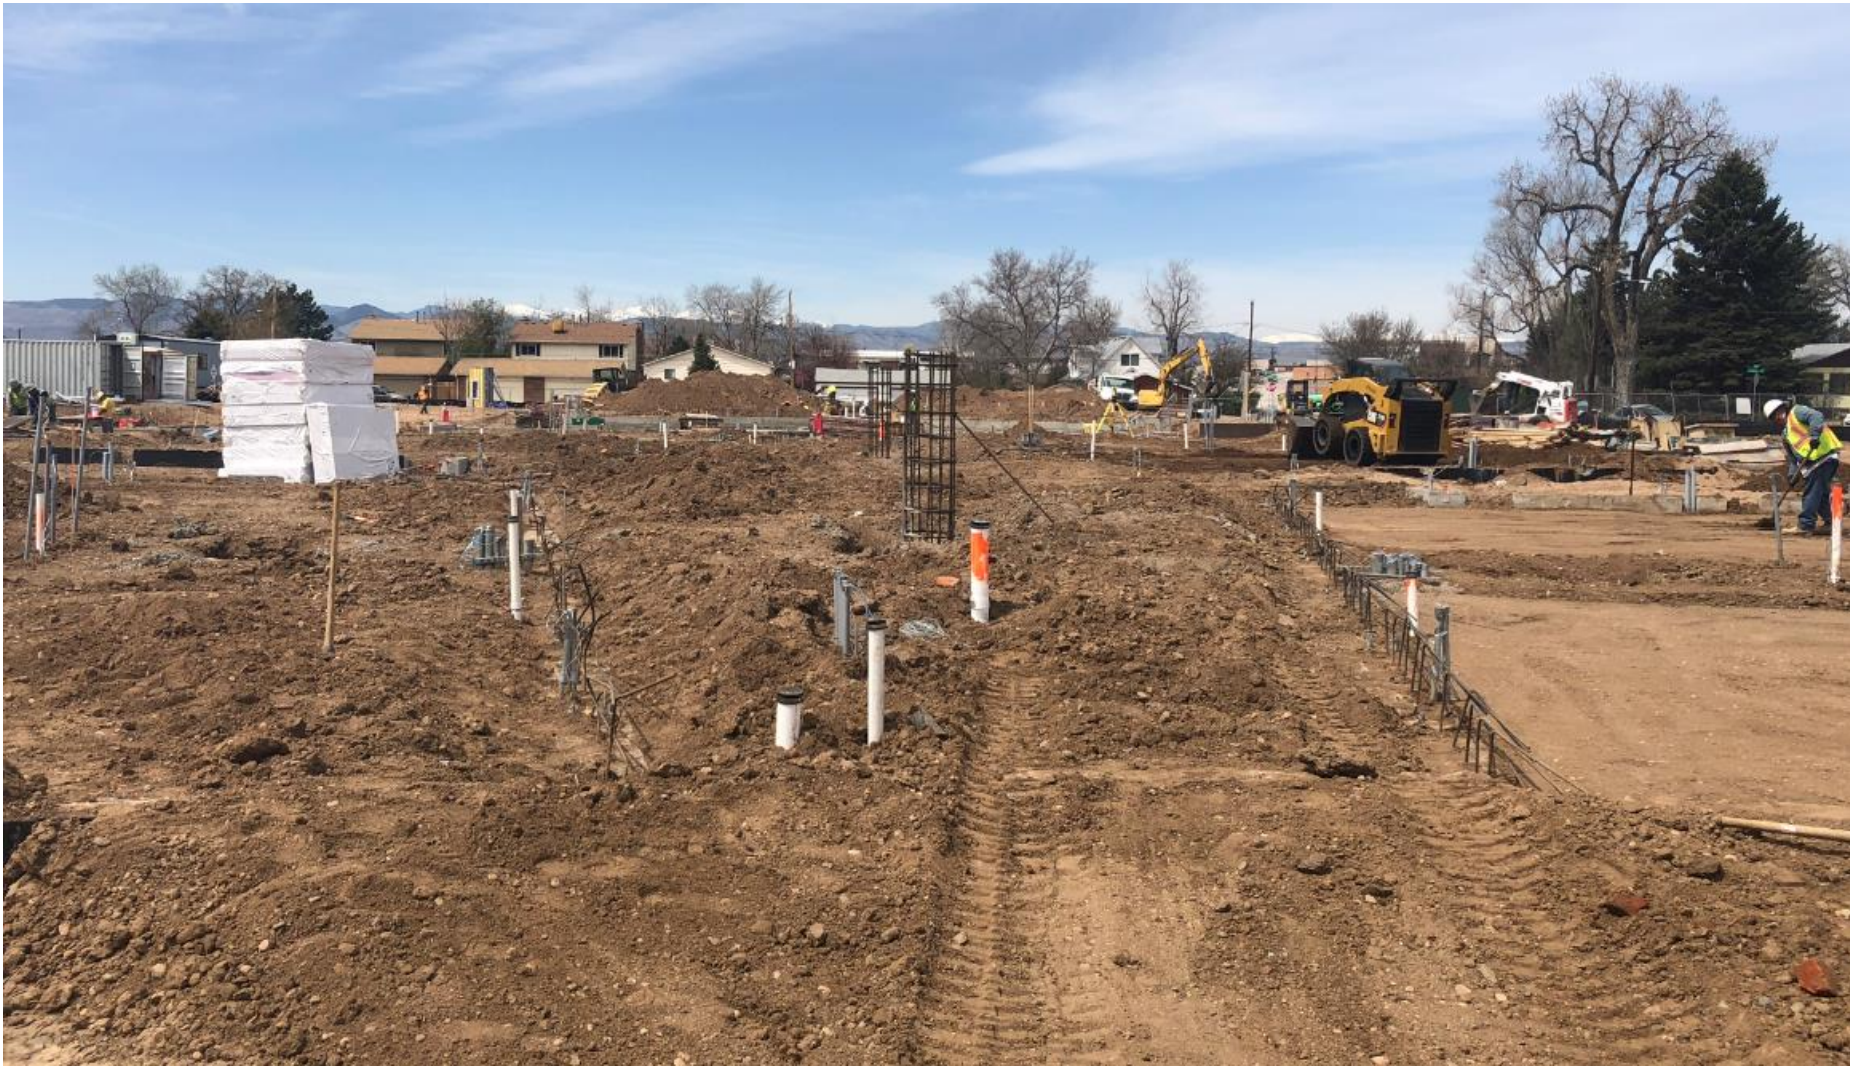
Looking West, rebar placed for columns.

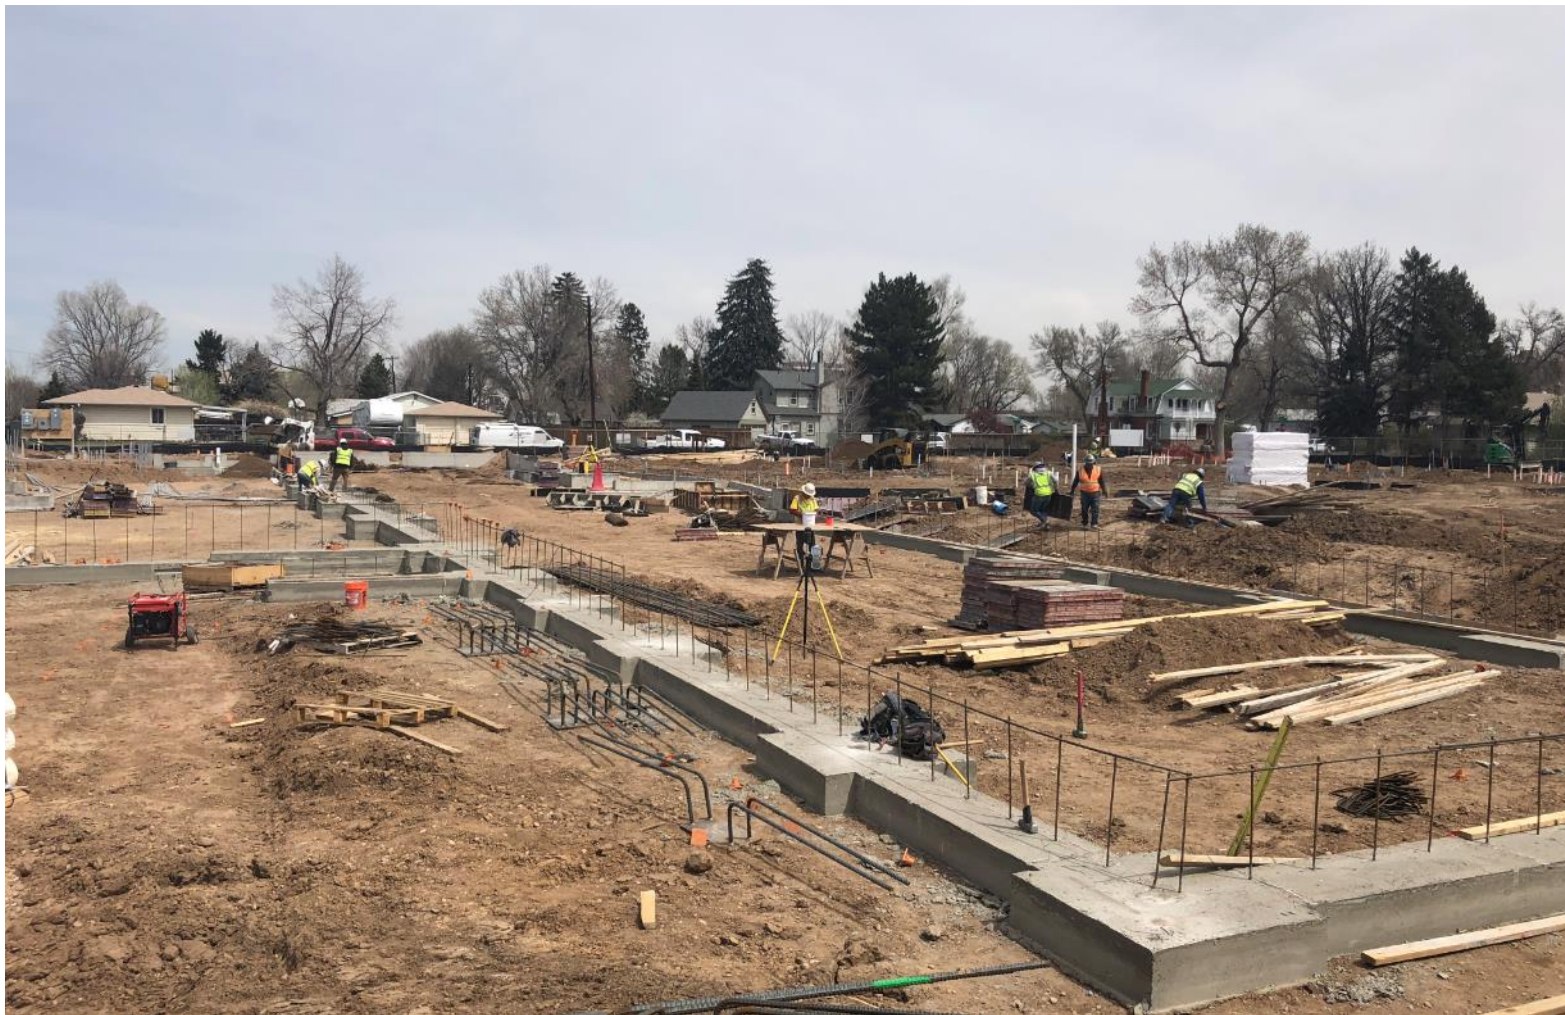
Looking North across Central body.

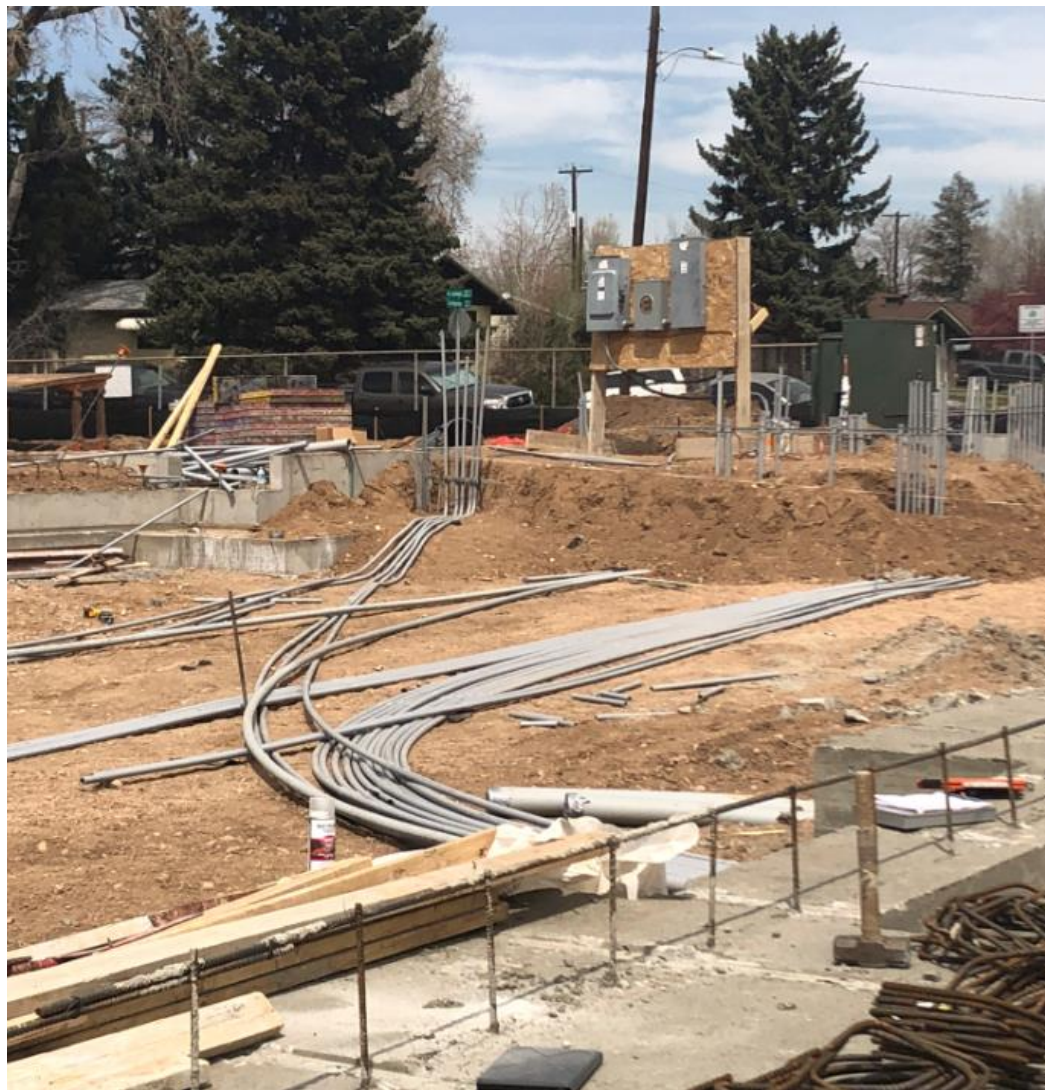
Underground conduit from electrical room.

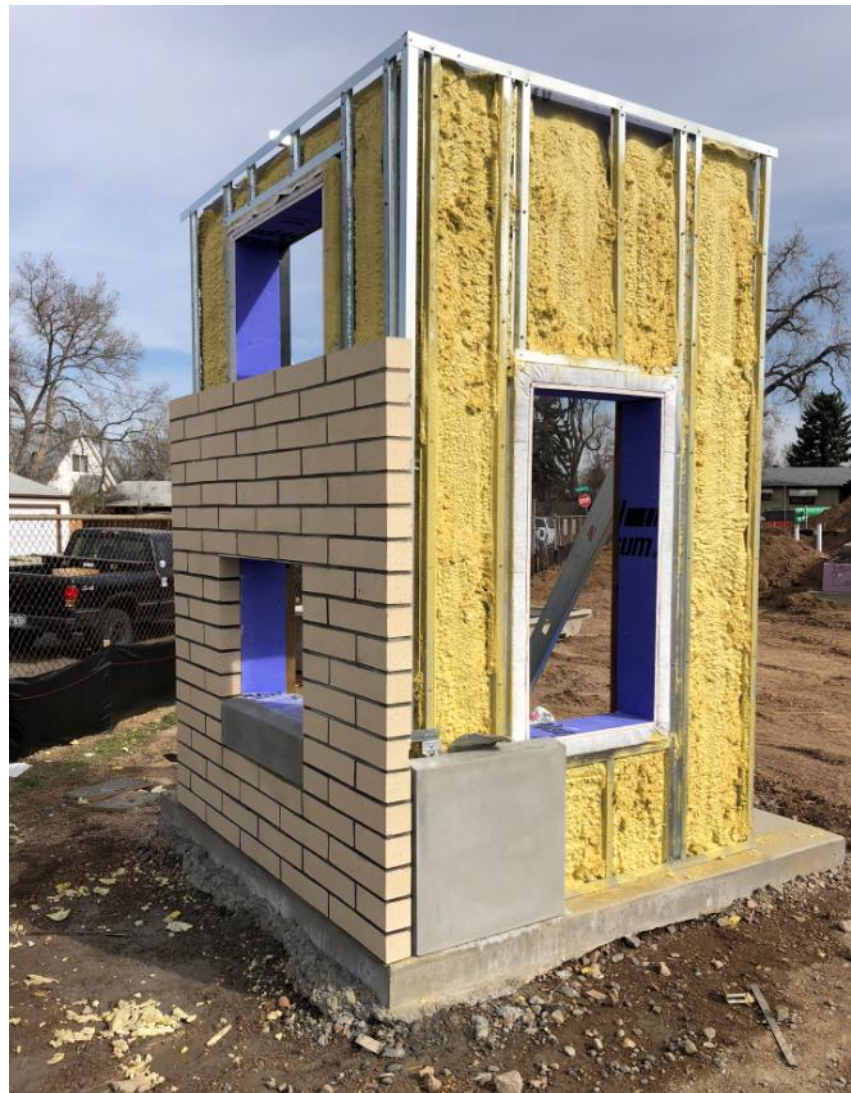
Mock up wall progression.
