## **CBRE CAFETERIA**, COMMONS & NORTH CLASSROOM WING (L1)

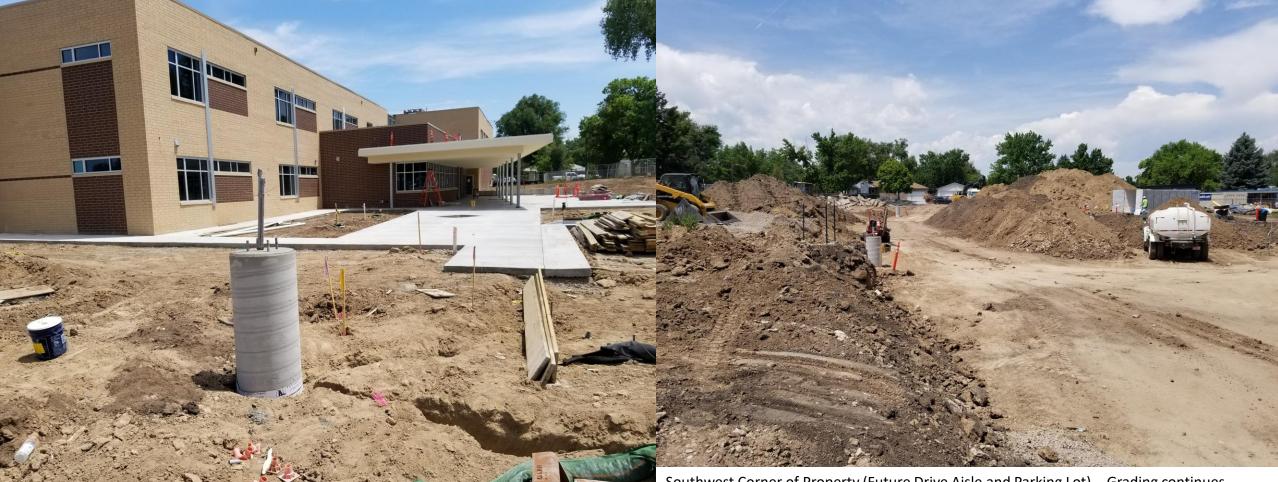
South Elevation – Main Entrance; Concrete work continues and installation of light poles.

Southwest Corner of Property (Future Drive Aisle and Parking Lot) – Grading continues and installation of light poles.

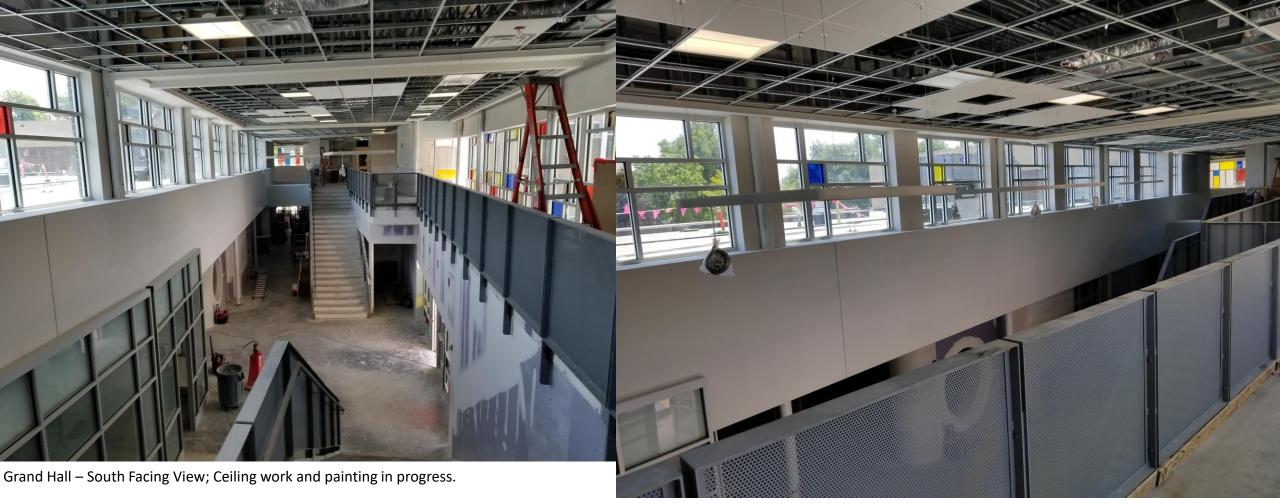
Grand Hall – East Facing View; Light pendants newly installed.

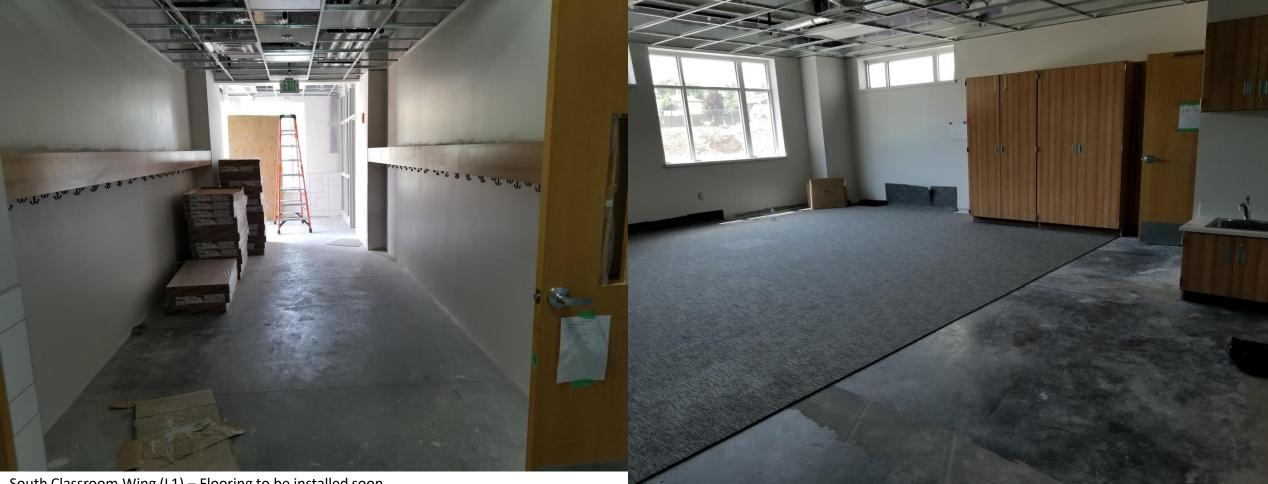
South Classroom Wing (L1) – Flooring to be installed soon.

South Classroom Wing (L1) – Classroom; Floor being installed. Carpet install nearly complete.

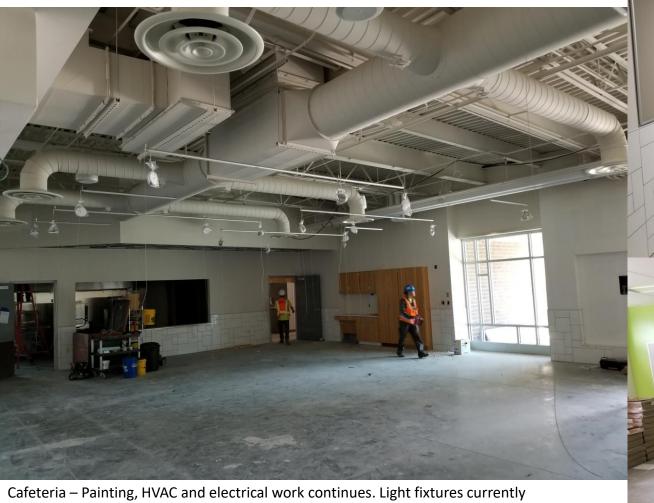
being installed.

North Classroom Wing (L1) – Carpet install continues. Tack boards newly installed.

North Classroom Wing (L1) – Classroom; Flooring complete. Tack and white boards newly installed.

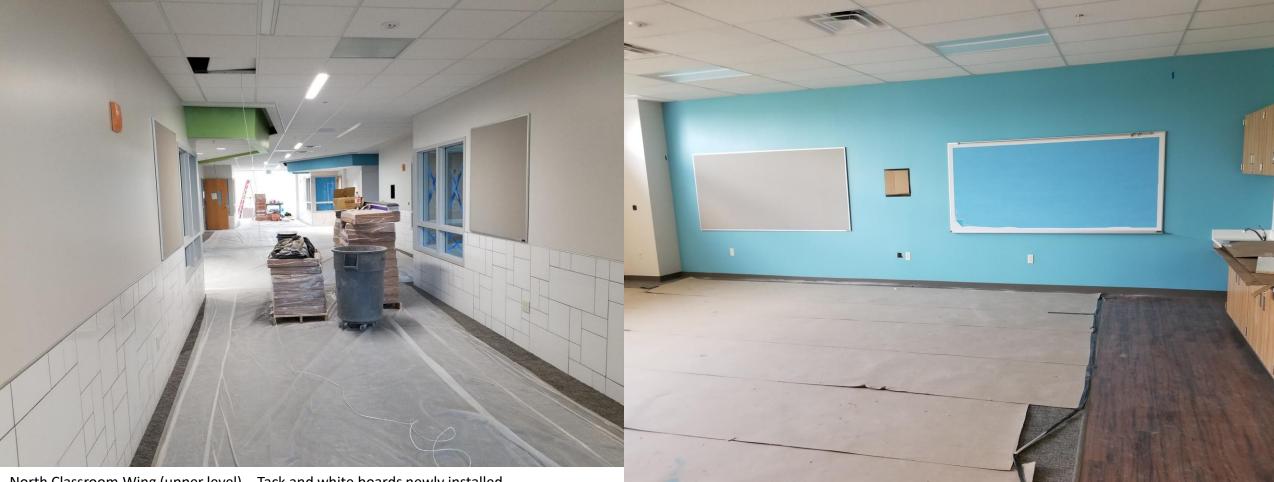
North Classroom Wing (upper level) – Tack and white boards newly installed.

North Classroom Wing (upper level) – Classroom: Tack and white boards newly installed.
