Maddox ECE Construction Report May 29, 2018

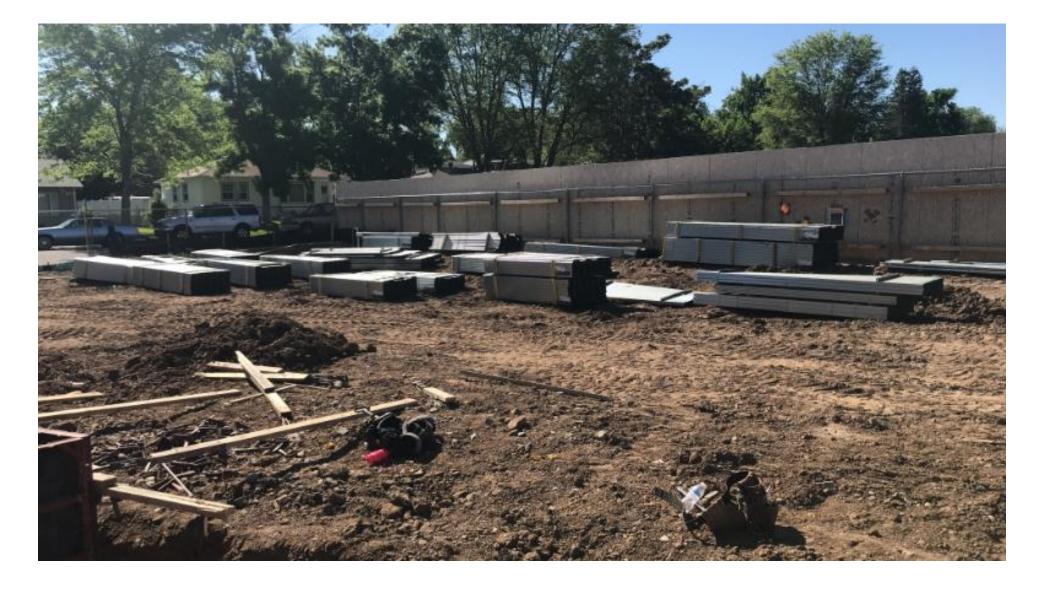
Steel studs on site to starting framing.

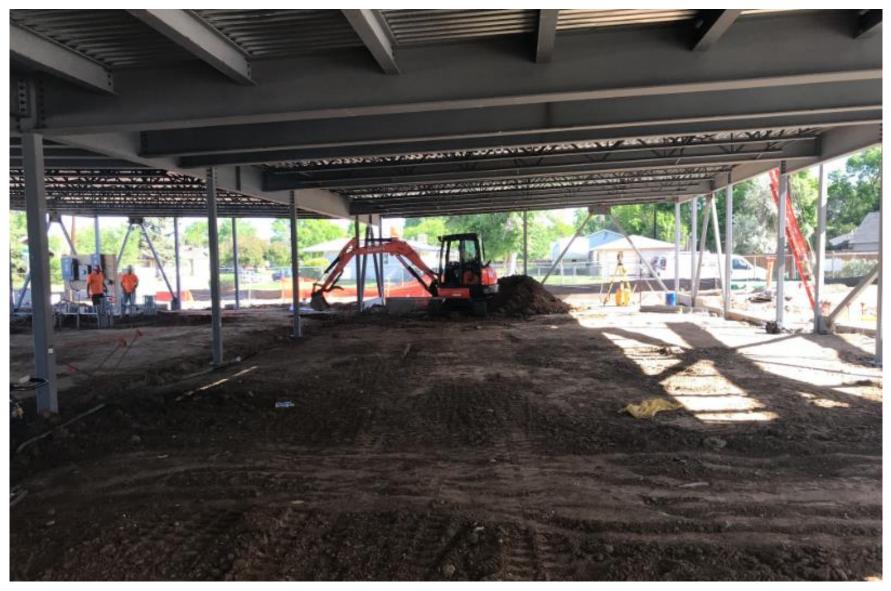
Looking North across central body. Decking installed.
