Maddox ECE Construction Report
August 13, 2018

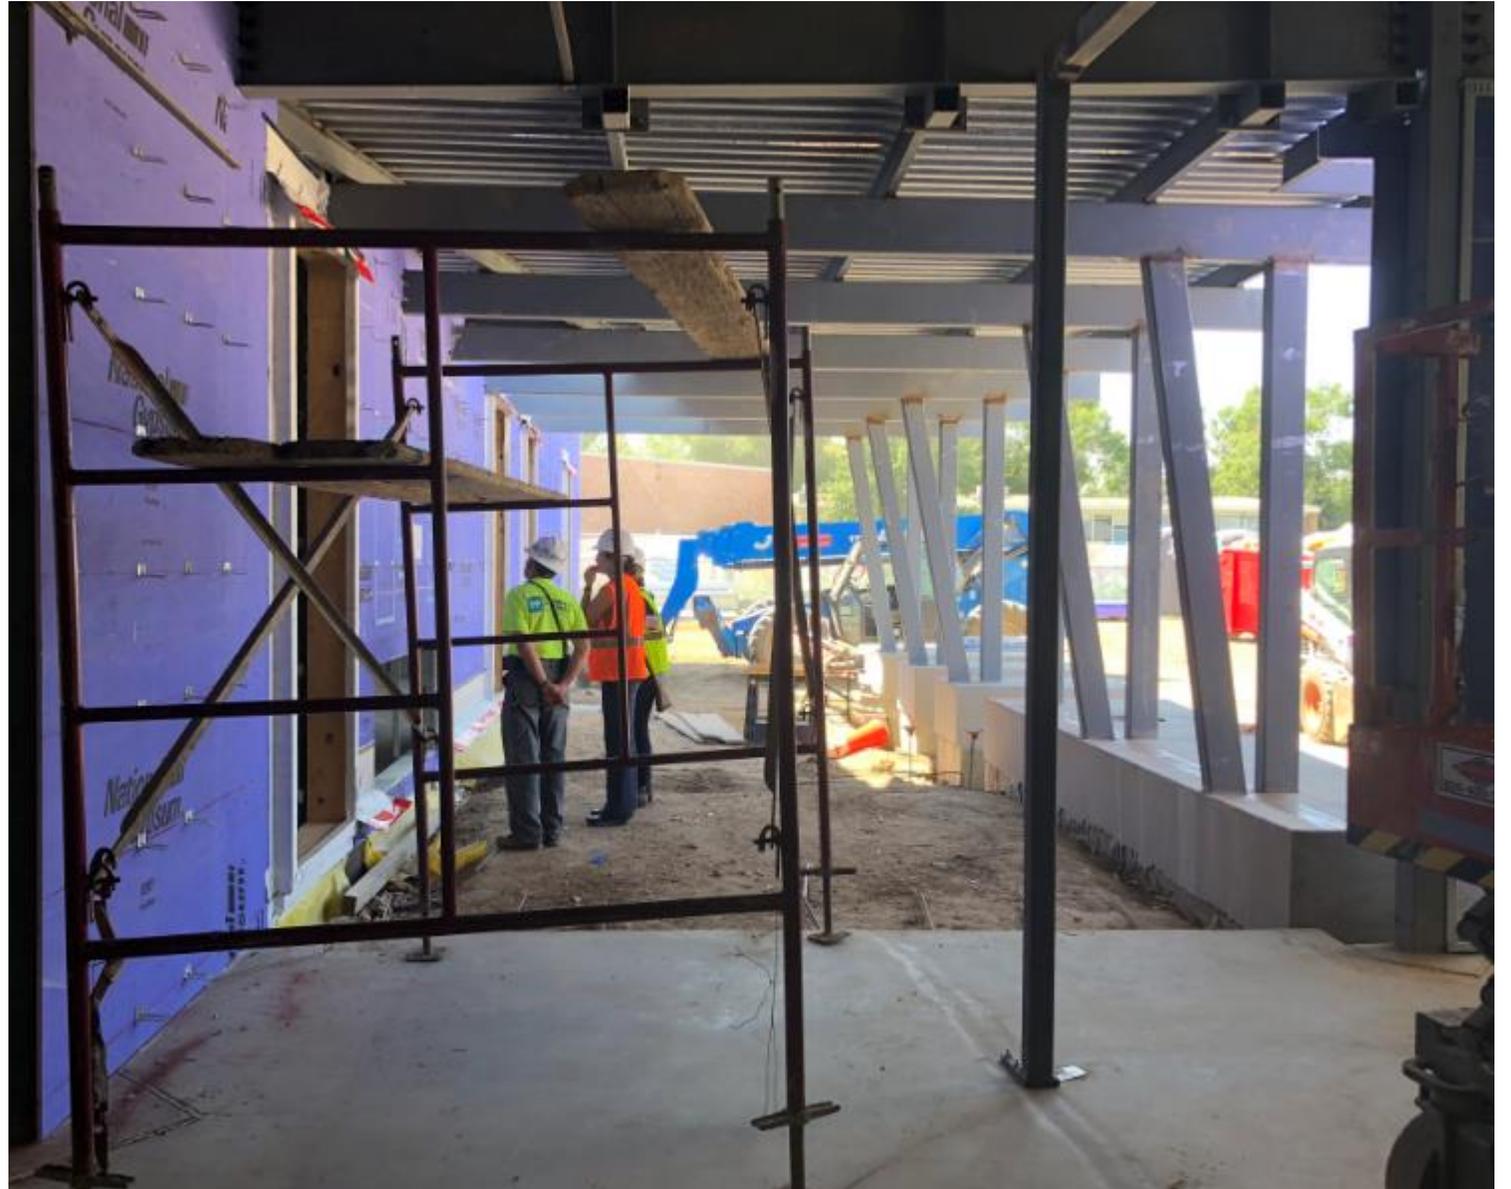
East side of building with siding installed.

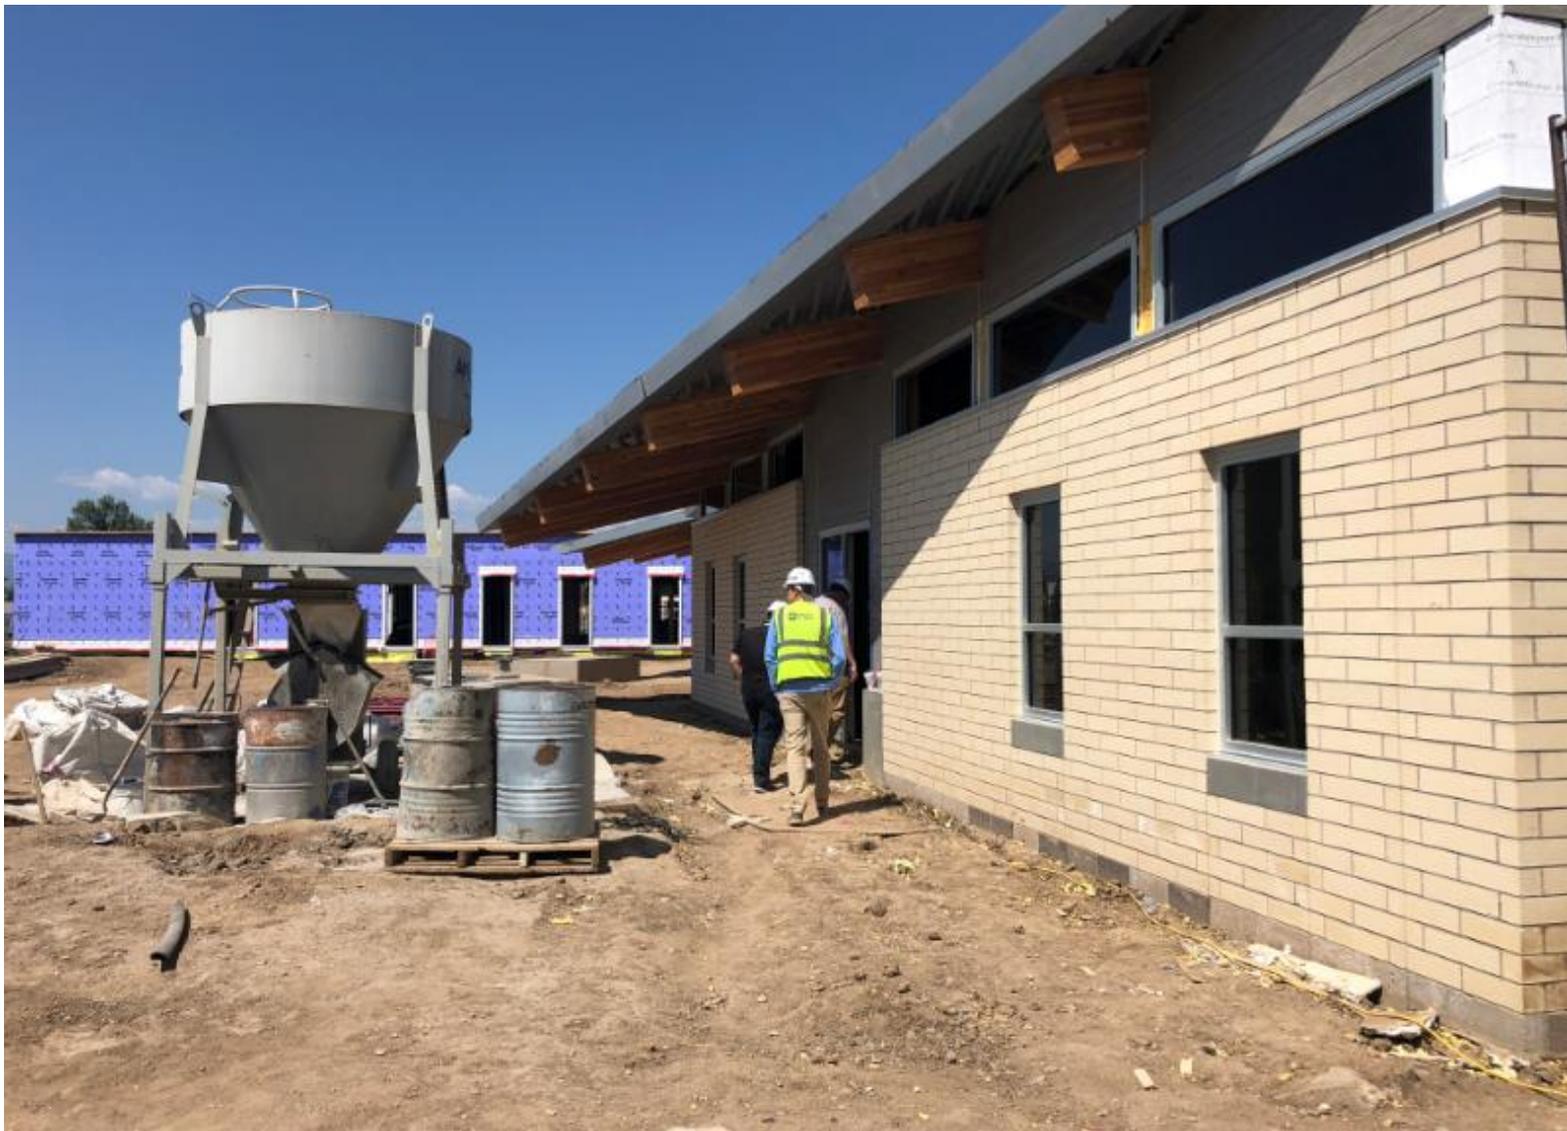
View of East wing.

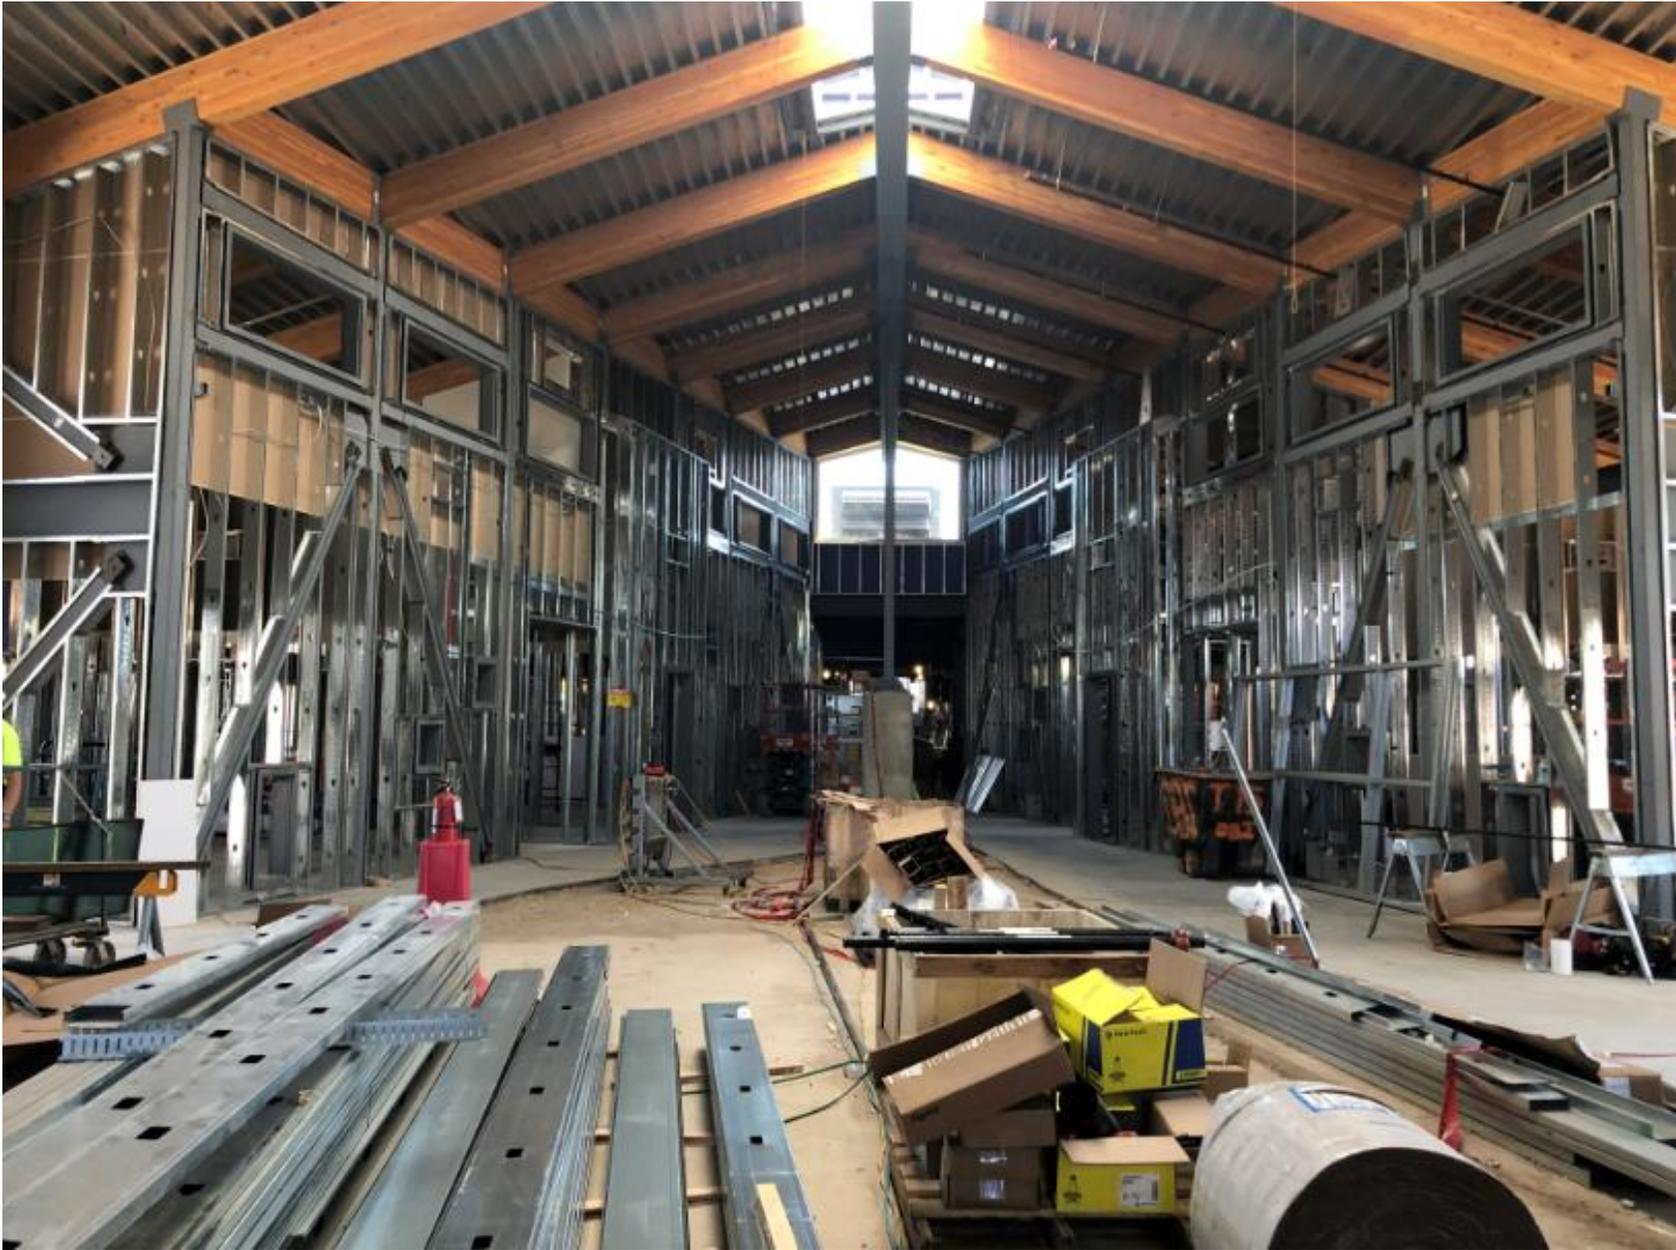
East wing interior.

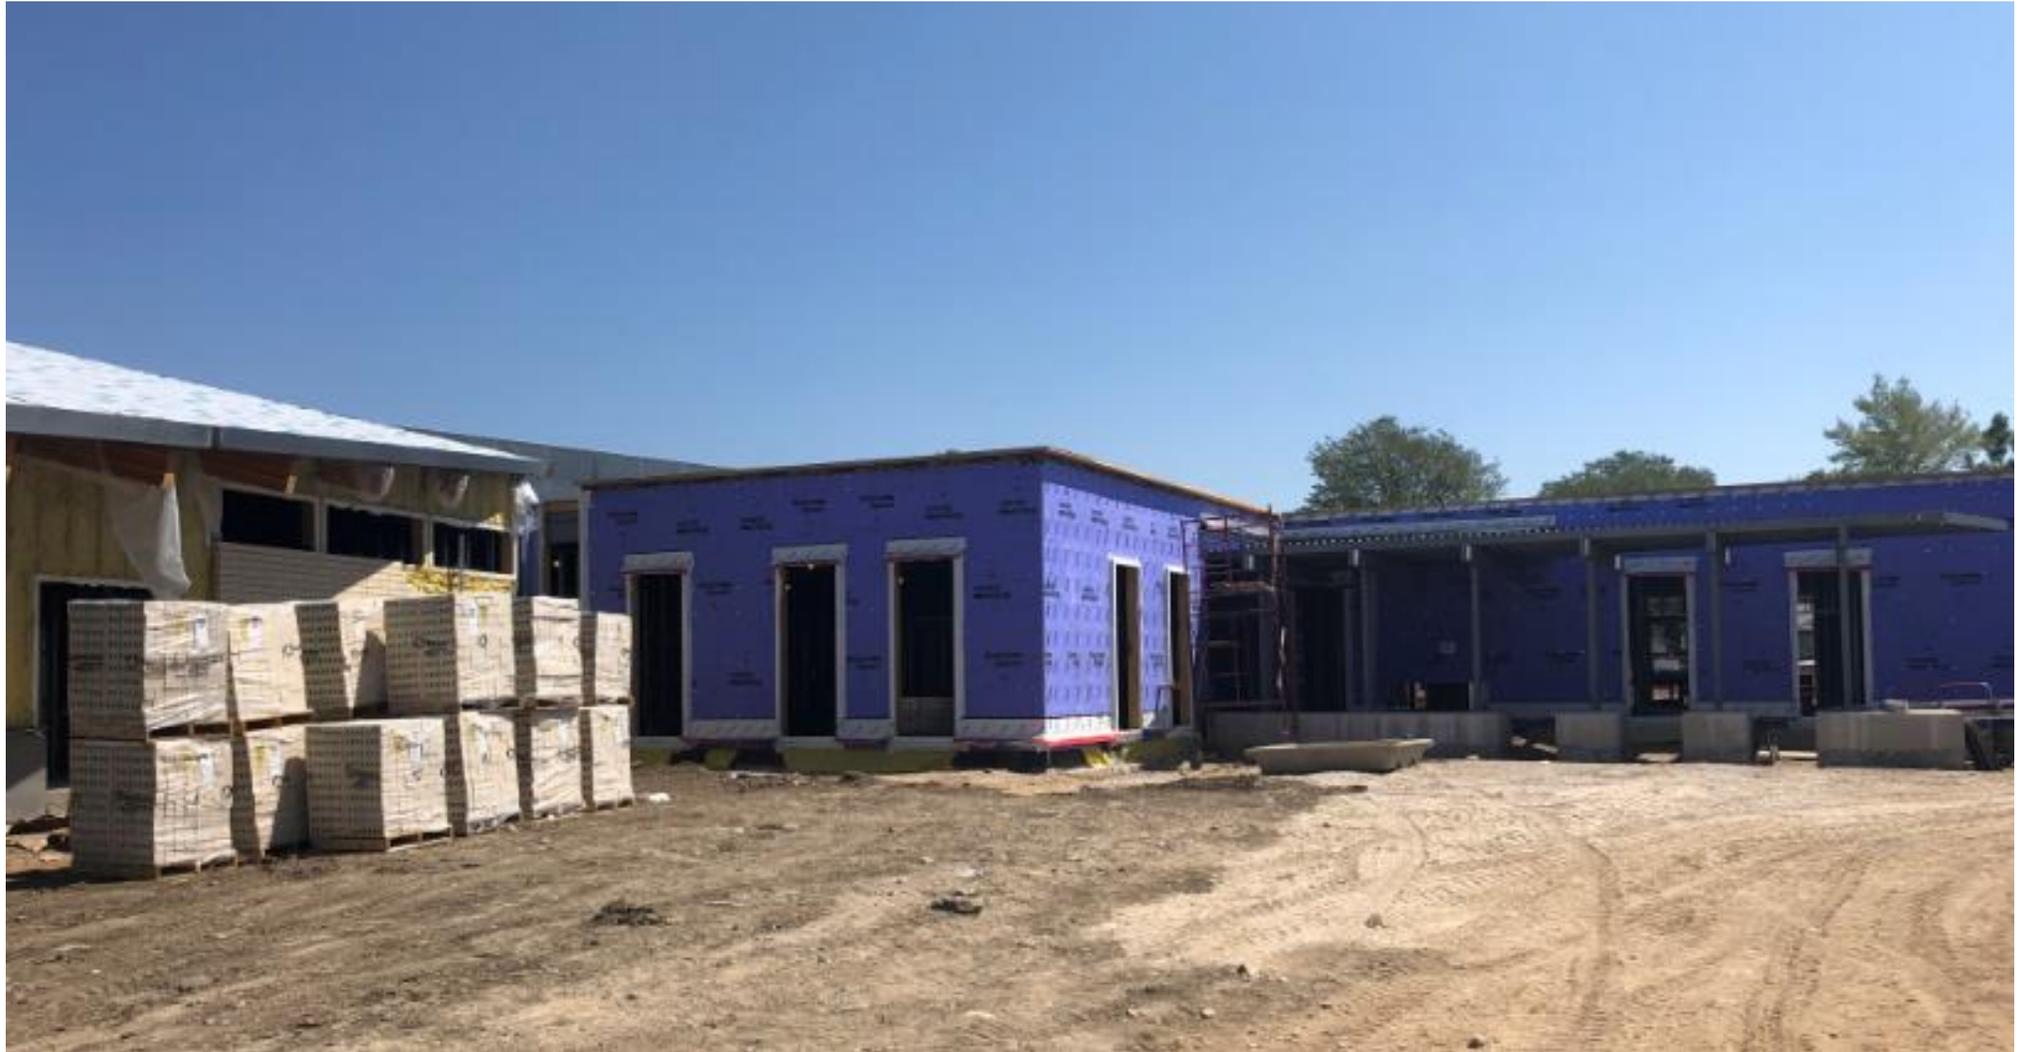
Central body exterior.
