Maddox ECE Construction Report

June 4, 2018

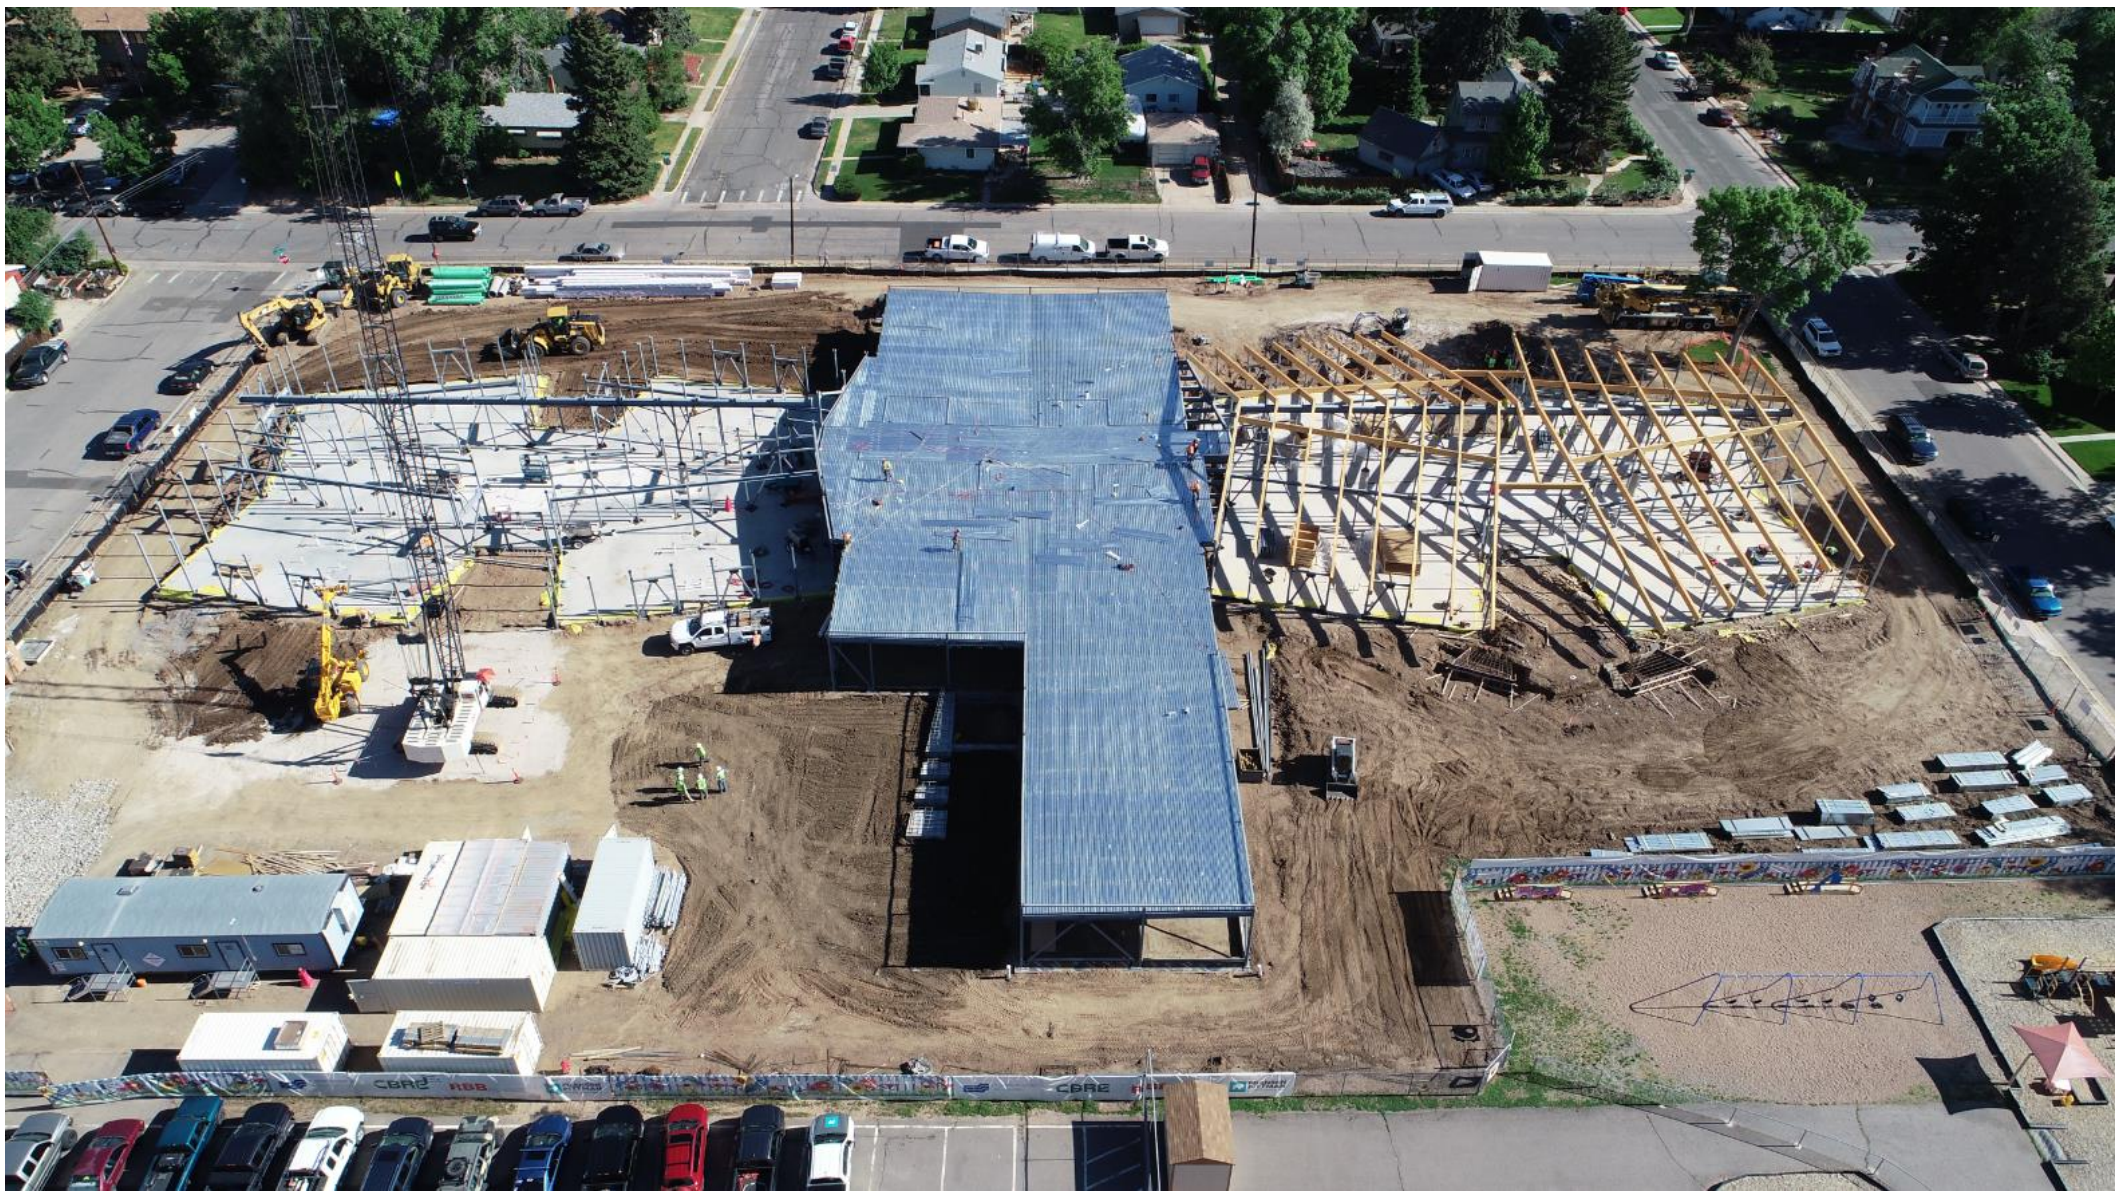
Entire building.

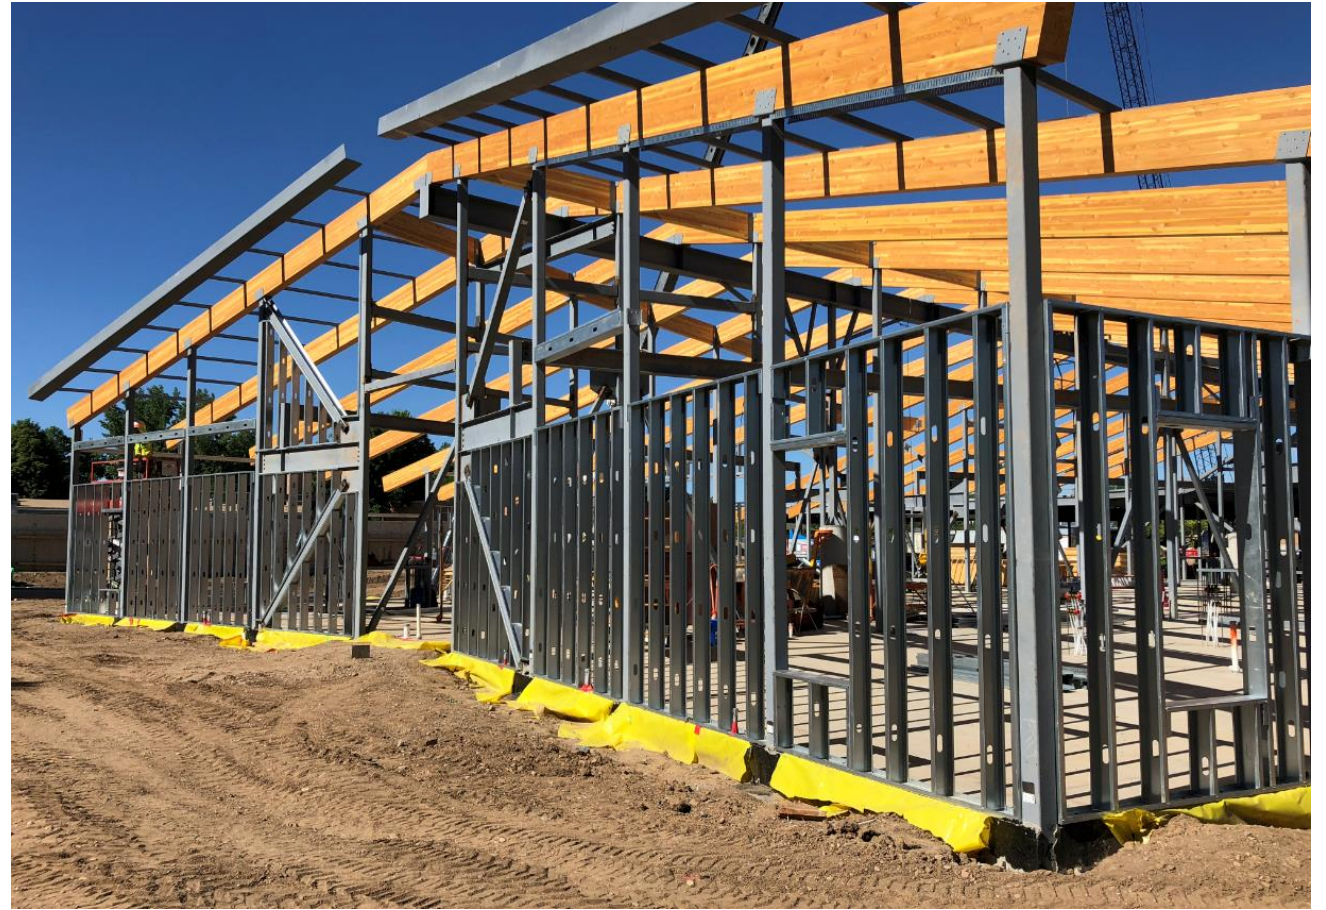
West wing. Exterior framing has started.

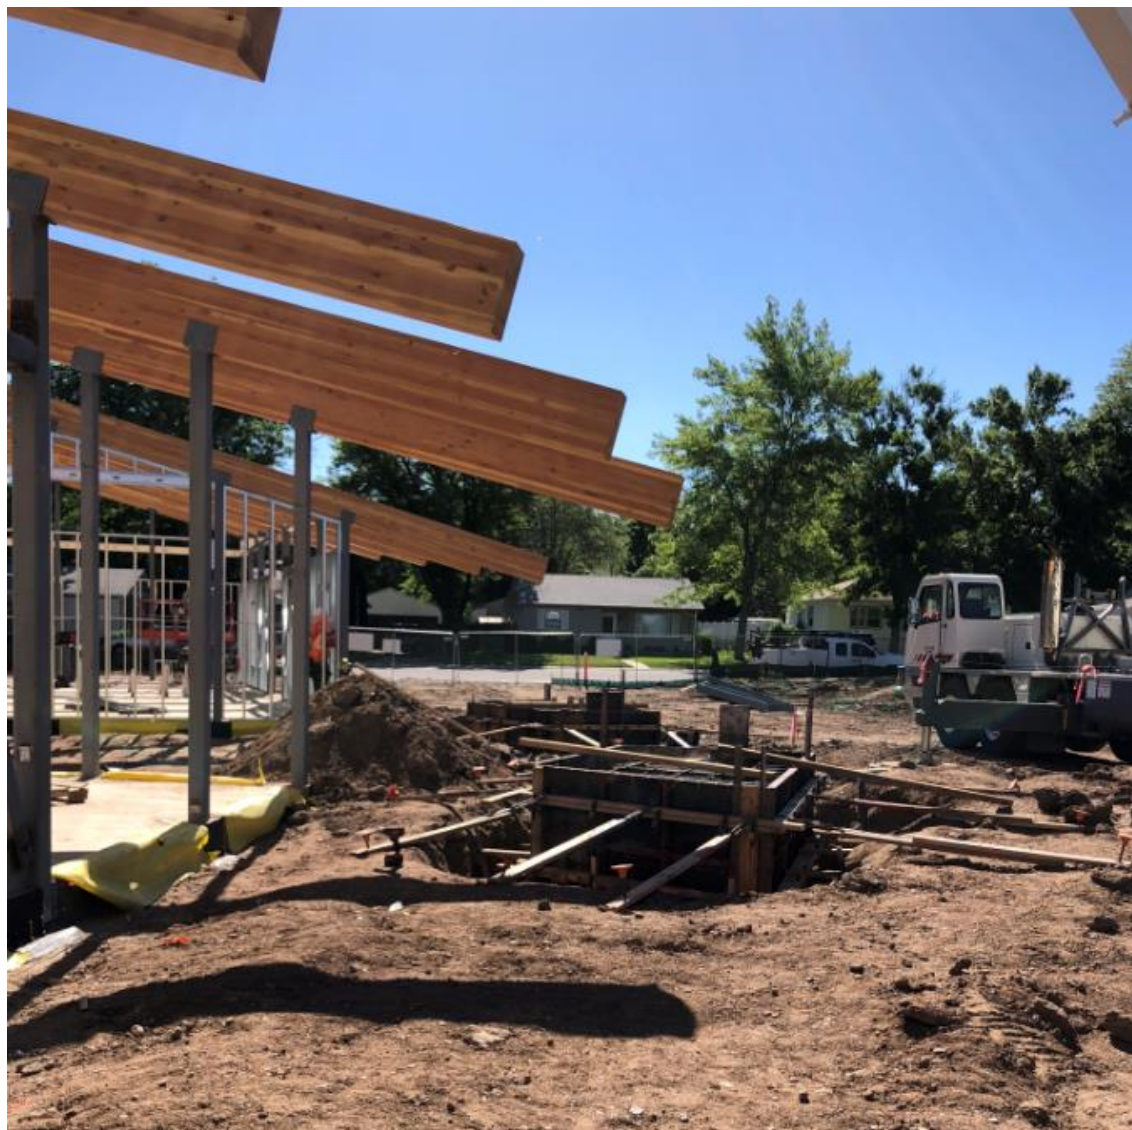
Rain chain foundations being formed.

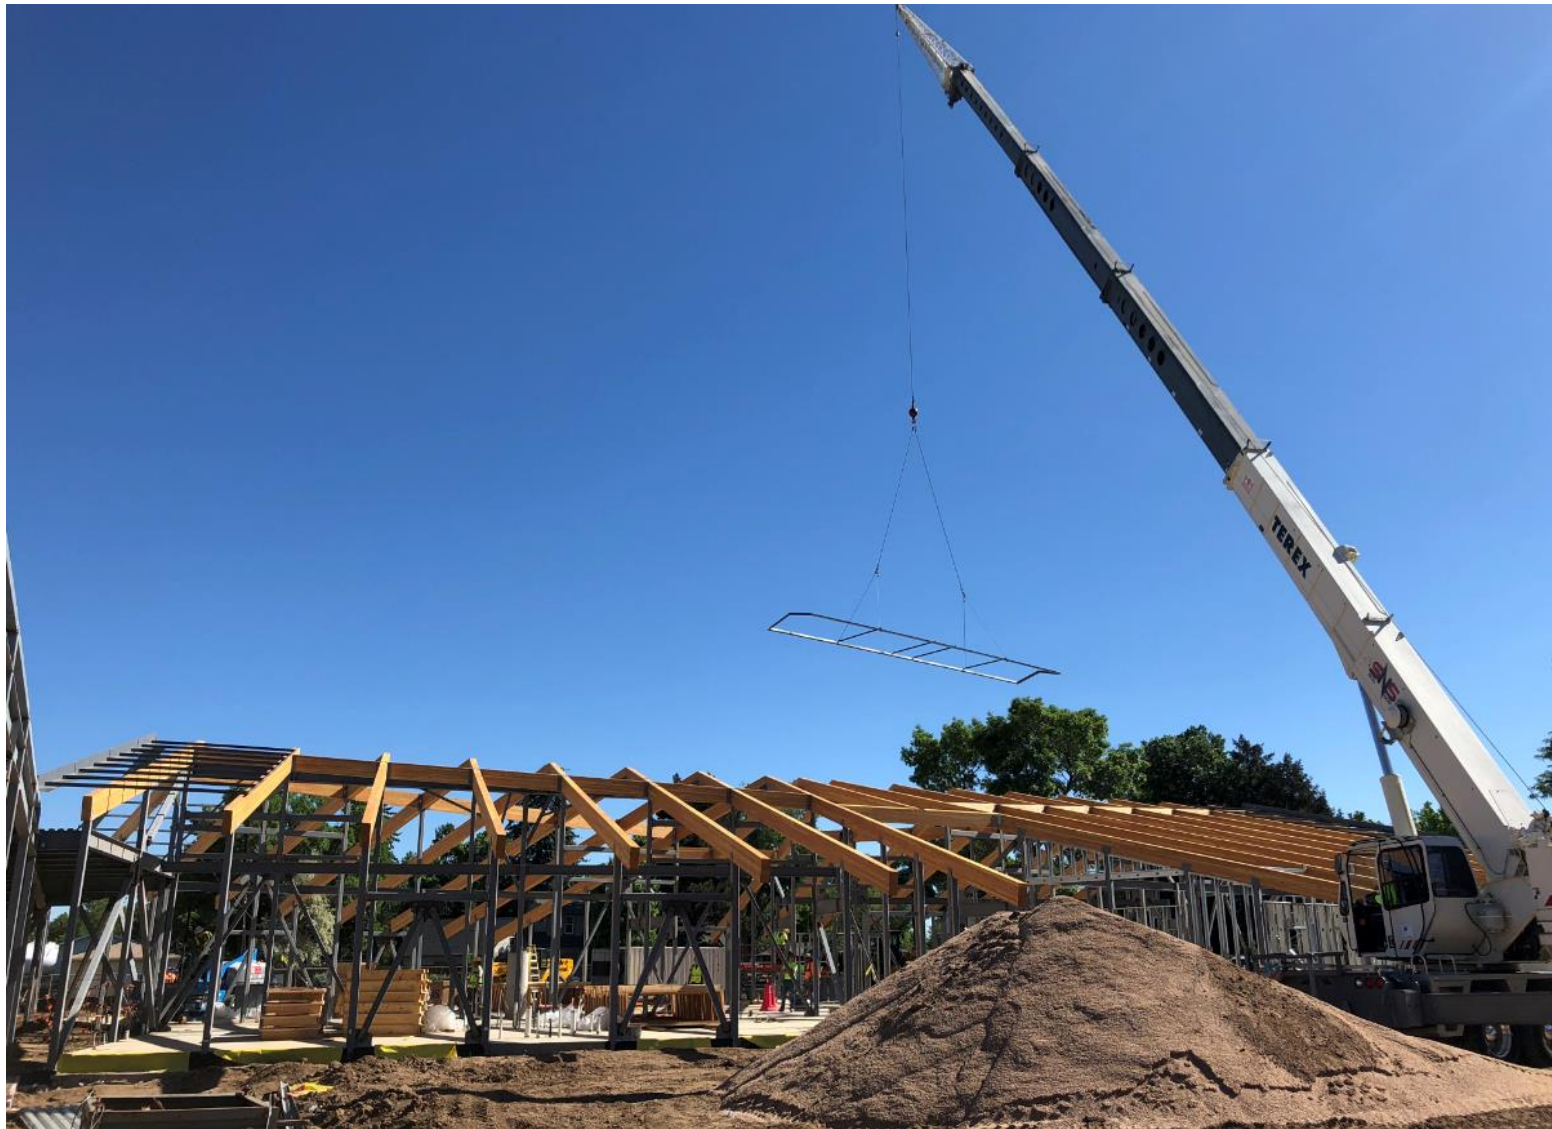
Installing steel frame for skylight.

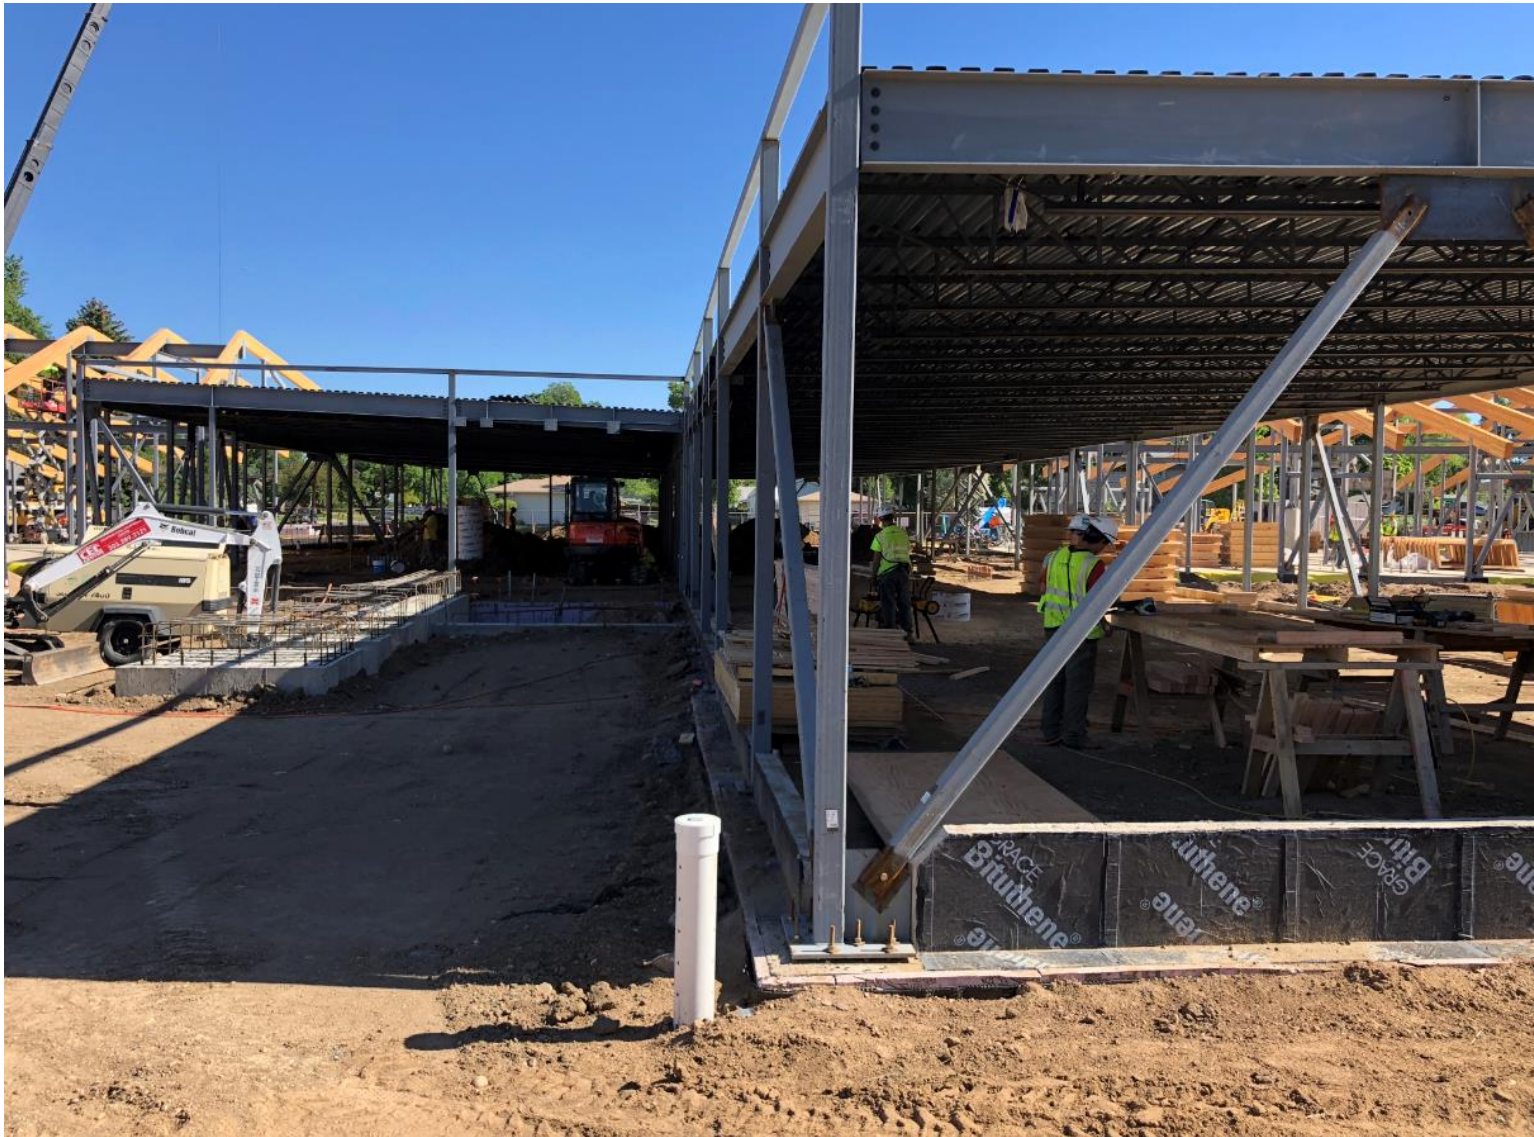
Central body, looking at main entrance area.

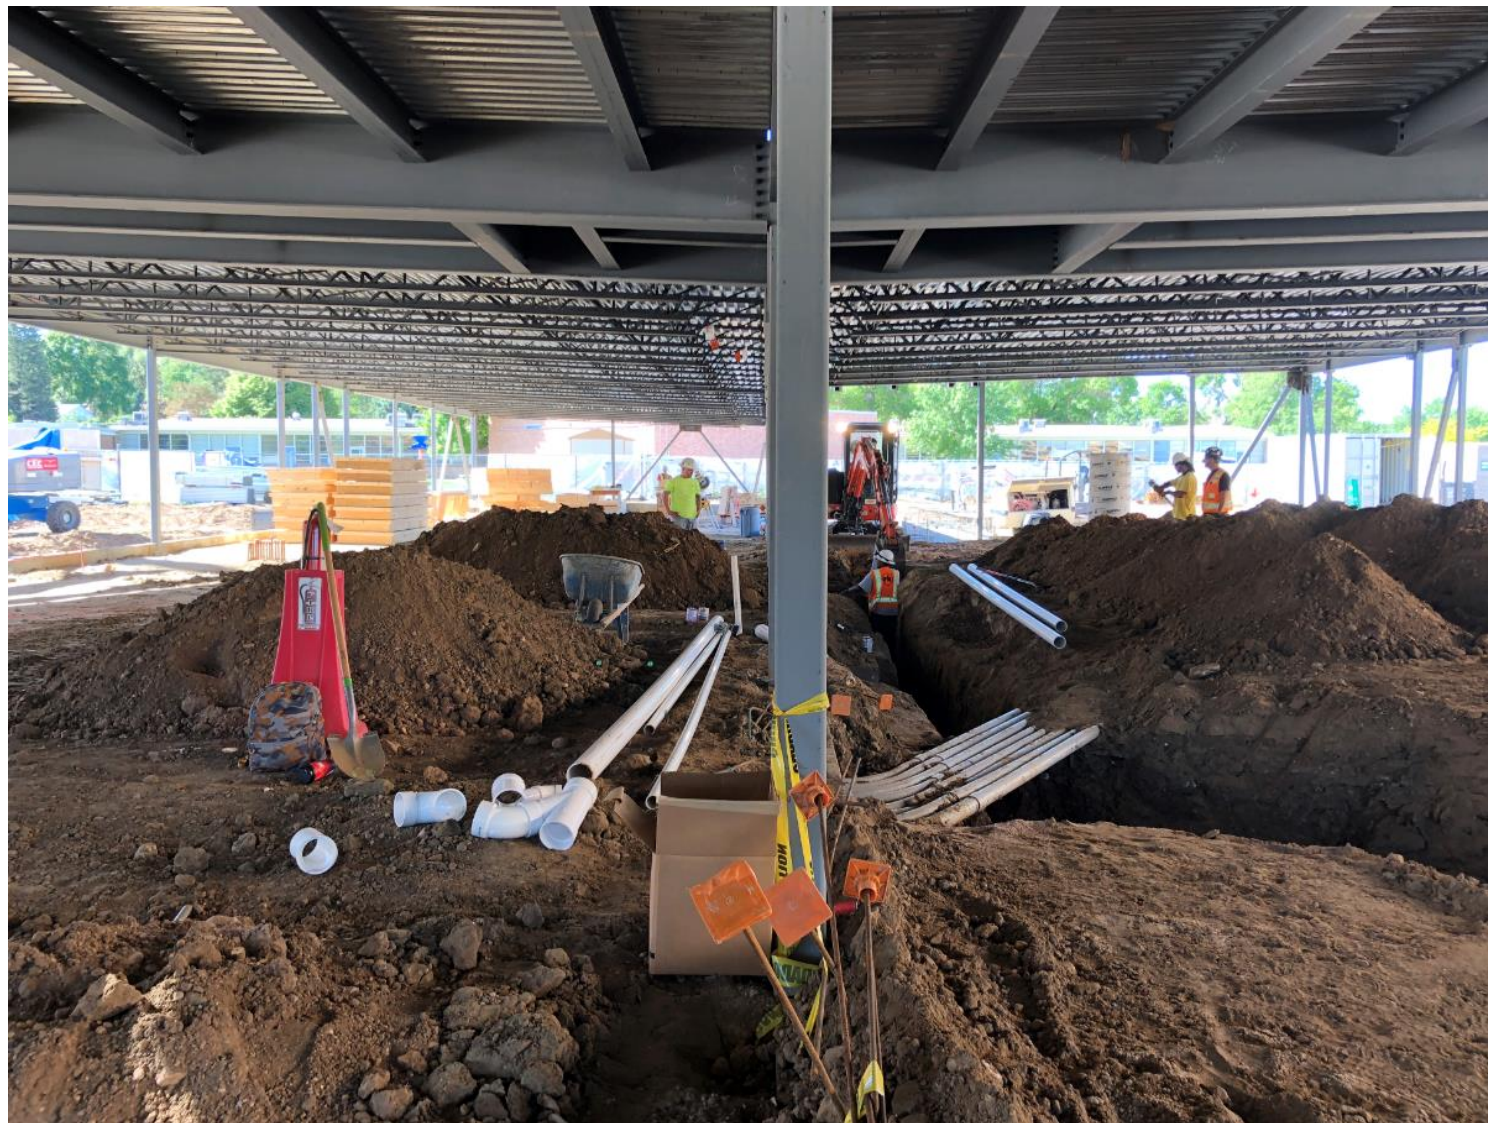
Looking North across central body. Plumbing trenches underway.
