Cherrelyn Construction Report December 26, 2018

CBRE North Wing/Gym

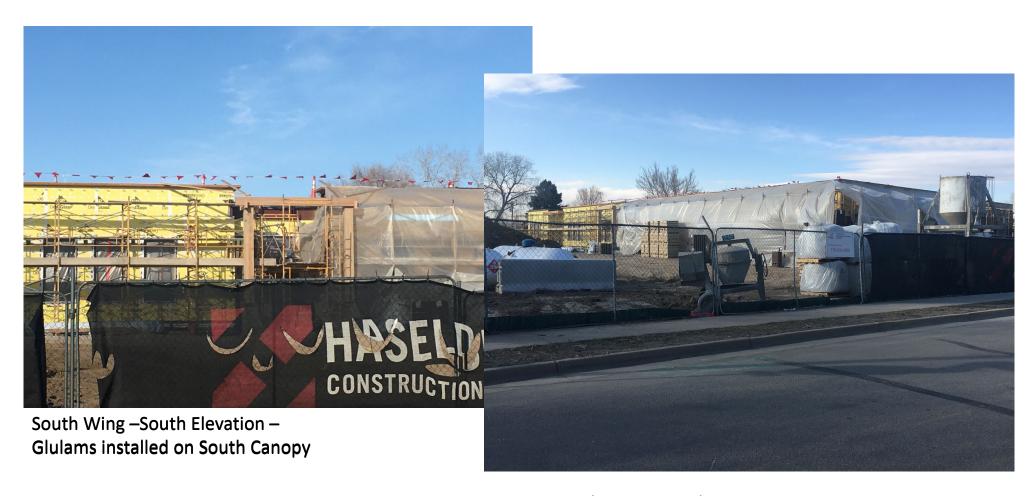
Center/South Wing – West Elevation (Windows are installed)
